**Flood Control Project Maintenance  
Levee Inspections**

**Maintenance Issue Types Only, Levee Inspection Report By Mile - Spring 2020**

**Reclamation District No. 2068 Yolo**

Waterway	Bank	Unit Miles	Inspection Start/End	Inspector
Unit No. 01 Yolo Bypass	Right	5.48	04/24/2020 04/24/2020	David Julian

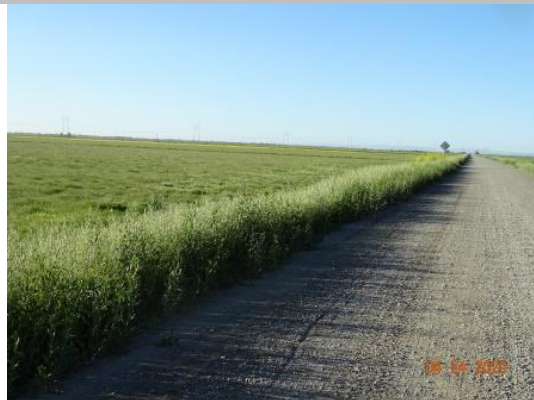
Photo 1 of 1 : SP\_2020\_RD2068\_193\_9\_20200424\_00018.jpg

LM Start	0.51	Rating **	U	Issue No.	9
LM End	5.45	Issue Type +	Ma	Location *	WS
Category	Earthen Levee			GPS Latitude/Longitude	
				Start	End
Item	Vegetation			38.401217 °	38.329537 °
				-121.693798 °	-121.694057 °
DWR ID	DWR_RD2068_01_s_2020_9				
Comment Code					
V1 : Control annual grass and weeds on the levee slopes and easements.					
Inspector Comment

View looking downstream at annual vegetation on the waterside slope (Spring 2020).

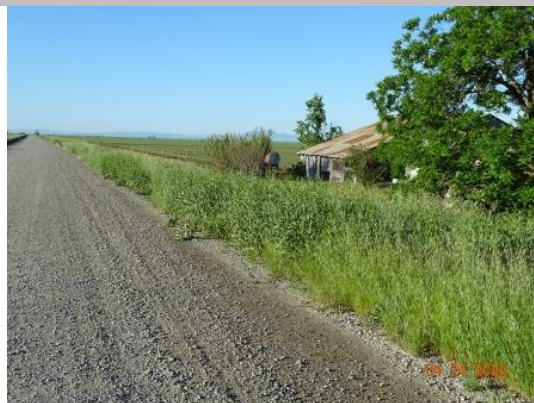
Photo 1 of 1 : SP\_2020\_RD2068\_193\_10\_20200424\_00019.jpg

LM Start	0.51	Rating **	U	Issue No.	10
LM End	5.45	Issue Type +	Ma	Location *	LS
Category	Earthen Levee			GPS Latitude/Longitude	
				Start	End
Item	Vegetation			38.401217 °	38.329537 °
				-121.693798 °	-121.694057 °
DWR ID	DWR_RD2068_01_s_2020_10				
Comment Code					
V1 : Control annual grass and weeds on the levee slopes and easements.					
Inspector Comment

View looking downstream at annual vegetation on the landside slope (Spring 2020).

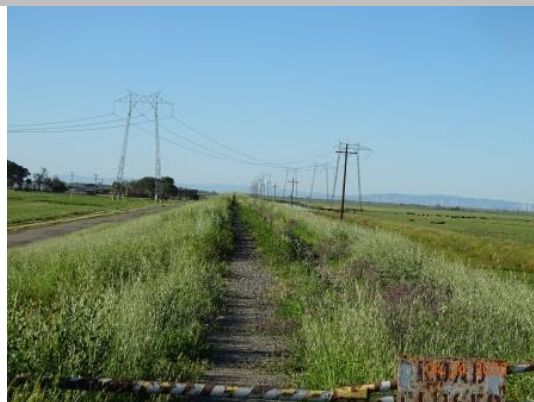
Photo 1 of 1 : SP\_2020\_RD2068\_193\_13\_20200424\_00020.jpg

LM Start	2.50	Rating **	U	Issue No.	13
LM End	5.45	Issue Type +	Ma	Location *	CR
Category	Earthen Levee			GPS Latitude/Longitude	
				Start	End
Item	Vegetation			38.372293 °	38.329537 °
				-121.693972 °	-121.694057 °
DWR ID	DWR_RD2068_01_s_2020_13				
Comment Code					
V9 : Keep the crown roadway free of vegetation.					
Inspector Comment

View looking downstream at vegetation on the crown (Spring 2020).

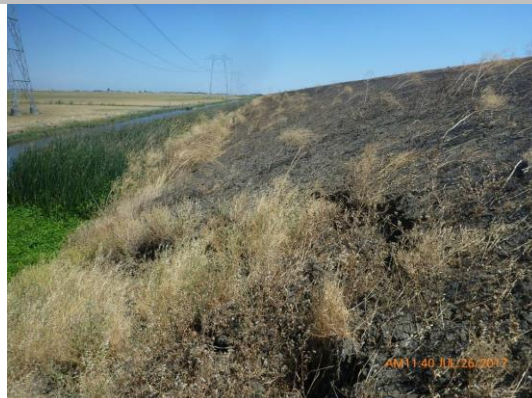
Photo 1 of 1 : SP\_2020\_RD2068\_193\_28\_20200304\_00011.jpg

LM Start	4.30	Rating **	A/W	Issue No.	28
LM End	4.31	Issue Type +	Ma	Location *	LS
Category	Earthen Levee			GPS Latitude/Longitude	
				Start	End
Item	Erosion / Bank Caving			38.346200 °	38.346100 °
				-121.694000 °	-121.694000 °
DWR ID	LMA-290				
Comment Code					
E1 : Note and monitor erosion site.					
Inspector Comment					
This was a 2017 Storm Damage site. The damage consists of scour, cracking, and sloughing of the lower landside levee slope. Site ID No:463 Site Designation:LMA-290 4/24/2020 Field Notes: Vegetation is too thick to view. Verify rating in the fall.

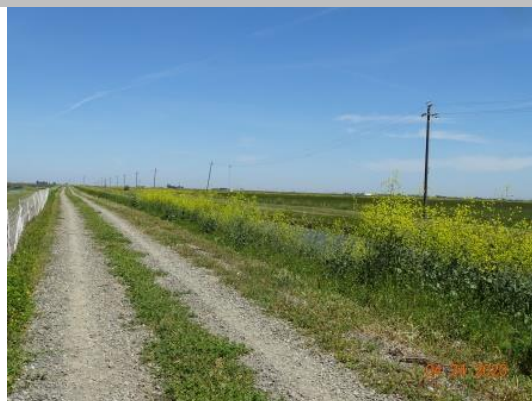
Photo 1 of 1 : SP\_2020\_RD2068\_194\_10\_20200424\_00008.jpg

LM Start	0.02	Rating **	U	Issue No.	10
LM End	0.84	Issue Type +	Ma	Location *	LS
Category	Earthen Levee			GPS Latitude/Longitude	
				Start	End
Item	Vegetation			38.358384 °	38.370323 °
				-121.740371 °	-121.740162 °
DWR ID	DWR_RD2068_02_f_2019_10				
Comment Code					
V1 : Control annual grass and weeds on the levee slopes and easements.					
Inspector Comment

View looking upstream at annual vegetation on the landside slope (Spring 2020).

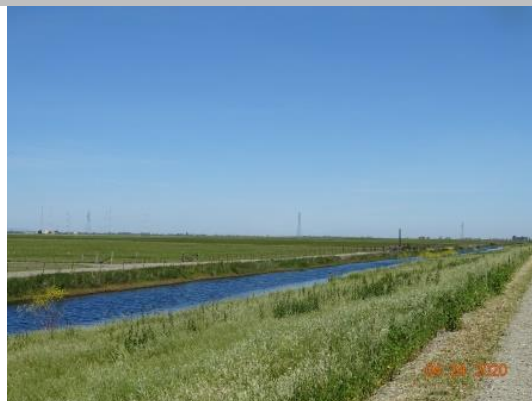
Photo 1 of 1 : SP\_2020\_RD2068\_194\_12\_20200424\_00009.jpg

LM Start	0.11	Rating **	M	Issue No.	12
LM End	0.84	Issue Type +	Ma	Location *	WS
Category	Earthen Levee			GPS Latitude/Longitude	
				Start	End
Item	Vegetation			38.359677 °	38.370323 °
				-121.740369 °	-121.740162 °
DWR ID	DWR_RD2068_02_s_2020_12				
Comment Code					
V1 : Control annual grass and weeds on the levee slopes and easements.					
Inspector Comment

View looking upstream at annual vegetation on the waterside slope (Spring 2020).

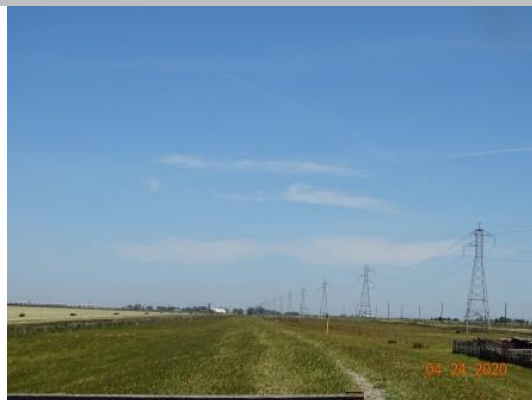
Photo 1 of 1 : SP\_2020\_RD2068\_194\_11\_20200424\_00010.jpg

LM Start	1.02	Rating **	M	Issue No.	11
LM End	3.22	Issue Type +	Ma	Location *	CR
Category	Earthen Levee			GPS Latitude/Longitude	
				Start	End
Item	Vegetation			38.372743 °	38.398730 °
				-121.739080 °	-121.715690 °
DWR ID	DWR_RD2068_02_s_2020_11				
Comment Code					
V9 : Keep the crown roadway free of vegetation.					
Inspector Comment

View looking upstream at vegetation on the crown (Spring 2020).

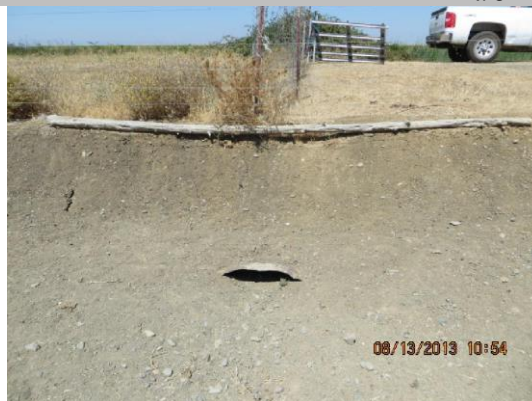
Photo 1 of 1 : UCIP\_SP\_2020\_42725\_29680.jpg

LM Start	3.15	Rating **	M	Issue No.	21	
LM End	3.15	Issue Type +	Ma	Location *		
Category	Supplemental			GPS Latitude/Longitude		
				Start	End	
Item	DWR UCIP LMA Responsibility			38.397933 °	38.397933 °	
				-121.716406 °	-121.716406 °	
DWR ID	19352

Comment Code						
Inspector Comment						
DS_ID:19352 FS_ID:42725 EP_NO: 10164 Repair Type: Non-Urgent Crossing Status: Found UCIP Comments: 09/14/2017 ABO issued as Permit No. 10164 defines the 48-inch pipe as a drainpipe. (DWR UCIP - O. Magana) 08/13/2013 Appears abandoned and if so should be done properly. Pipe burried except for small opening. (DWR UCIP - W. Wylie) FIELD_STRUCT_DESC: *ABANDONED* 48-inch corrugated metal drainage pipe through the levee, 4 feet below the crown. (48-inch pipe [HLM 3.20] authorized under Automatic Board Order (ABO) issued as Permit No. 10164, 1974 - Reclamation District No. 2068). [Additional Reference(s): DWR Levee Log, 1992. USACE Sacramento O&M Manual 109, April 1962, (HLM 3.20)]. FS Date: 8/13/2013

Pipe burried but visible at toe of east side of levee.
